**QUIET CLEAN SHORT-HAUL EXPERIMENTAL ENGINE
(QCSEE)**

**Under-the-Wing (UTW) Engine Boilerplate Nacelle Test Report
VOLUME III**

Mechanical Performance

**Advanced Engineering and Technology Programs Department
GENERAL ELECTRIC COMPANY**

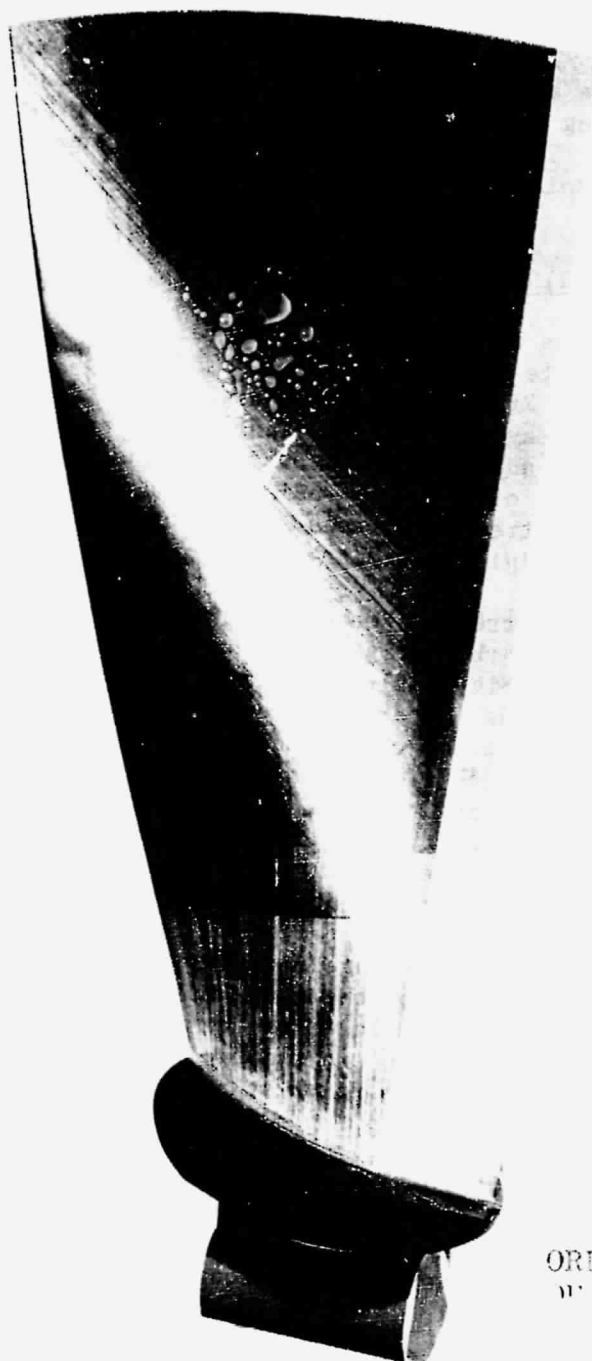
Figure 1. QCSEE UTW Composite Blade with Platform (C76011062).

The blade is made up of 0.25-mm (0.010-in.) plies of Kevlar 49, AS graphite, boron, and S-glass fibers impregnated with PR288 epoxy resin. The S-glass plies are placed near the surface in the lower region of the blade to provide high tensile strength and high strain-to-failure characteristics for flexural loading. Boron and graphite torsional stiffening plies in the airfoil region of the blade are oriented at $\pm 45^\circ$ to provide the shear modulus required for a high first-torsional frequency. The boron plies are placed toward the outer surface and graphite in the inner regions. Plies of Kevlar 49 are interspersed throughout the blade with the majority of them being oriented with their fibers in the longitudinal direction of the blade. Several Kevlar 49 plies in the tip region of the blade are oriented at 90° to the longitudinal axis to provide chordwise strength and stiffness to the blade. All airfoil plies extend continuously down into the dovetail and are

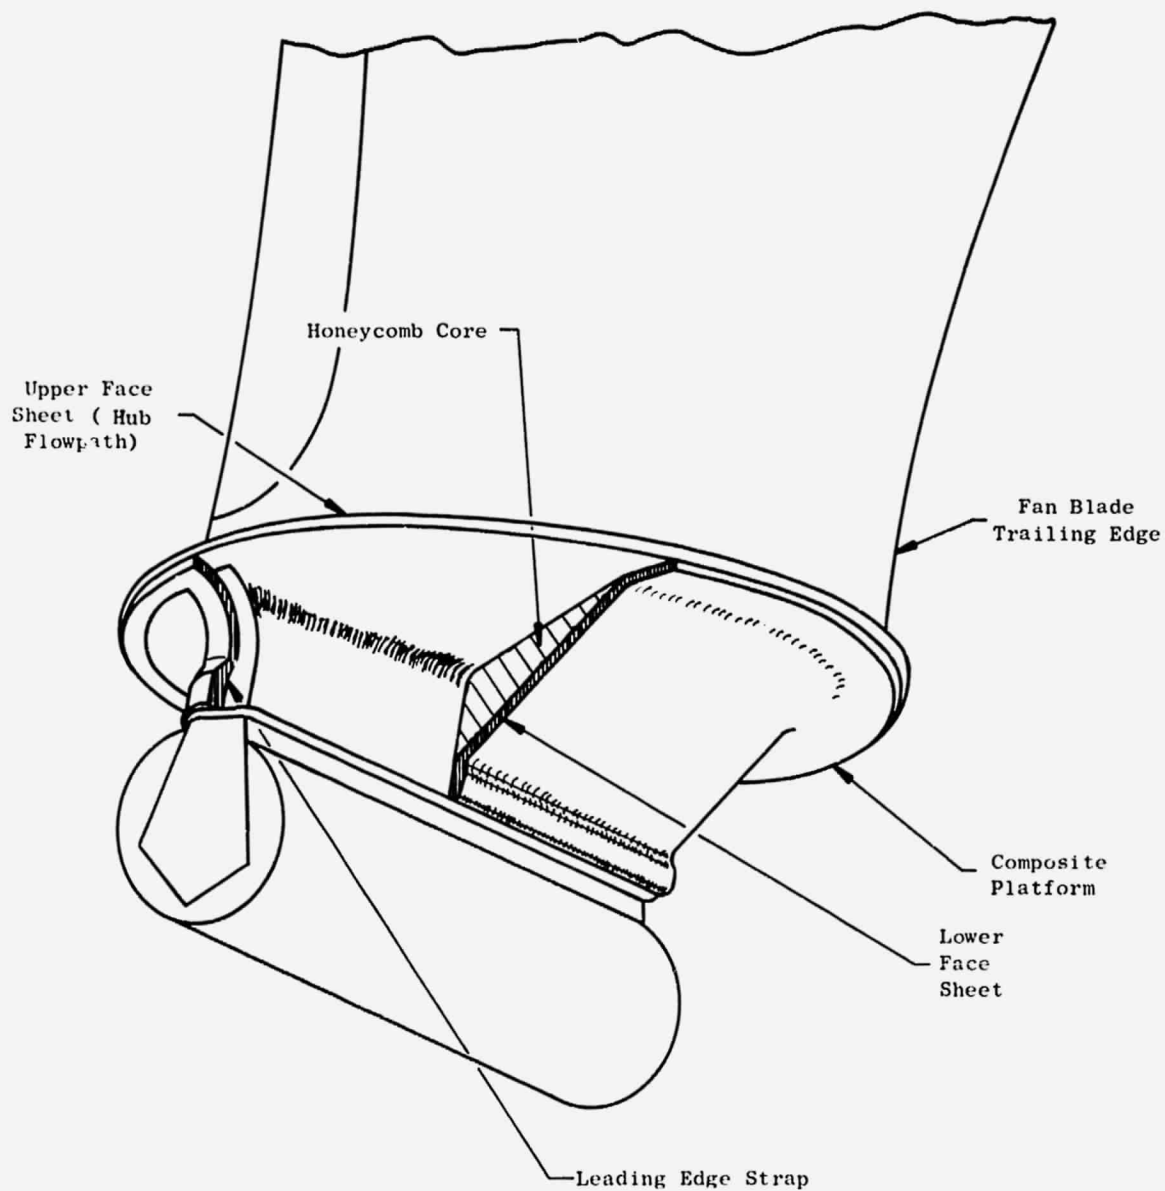
Figure 2. Platform Construction.

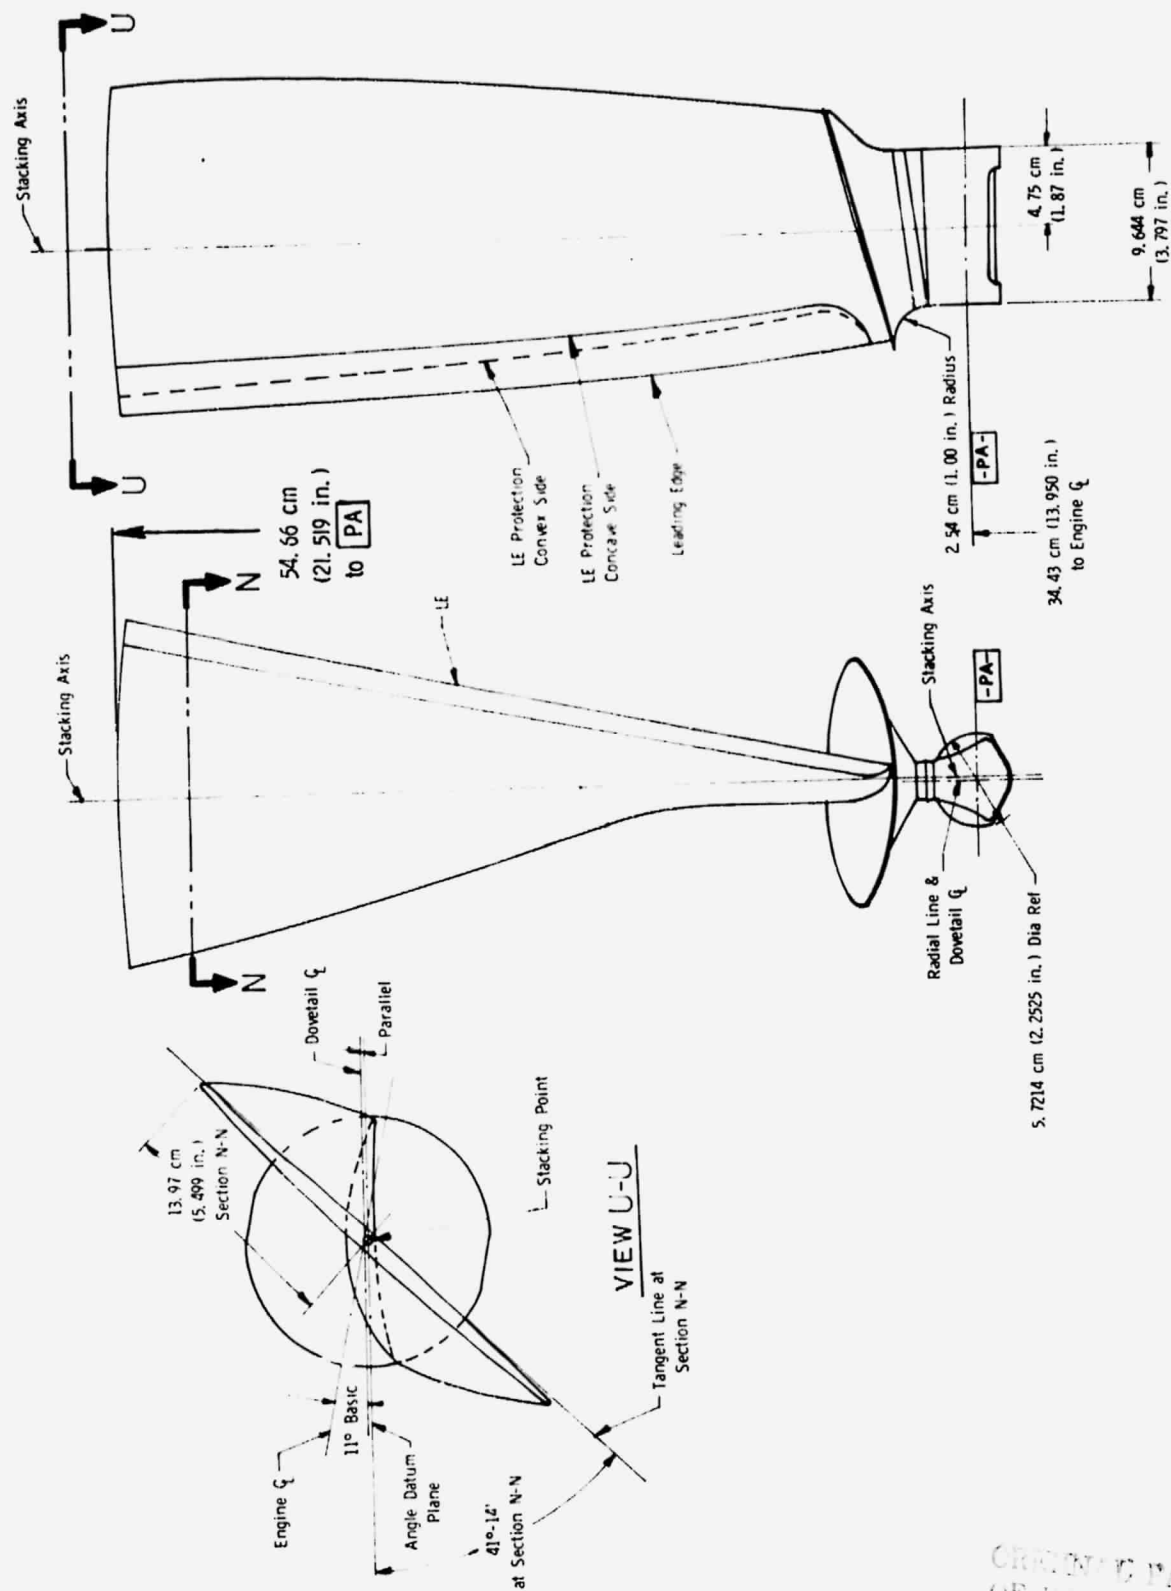
Figure 3. Composite Blade Configuration.

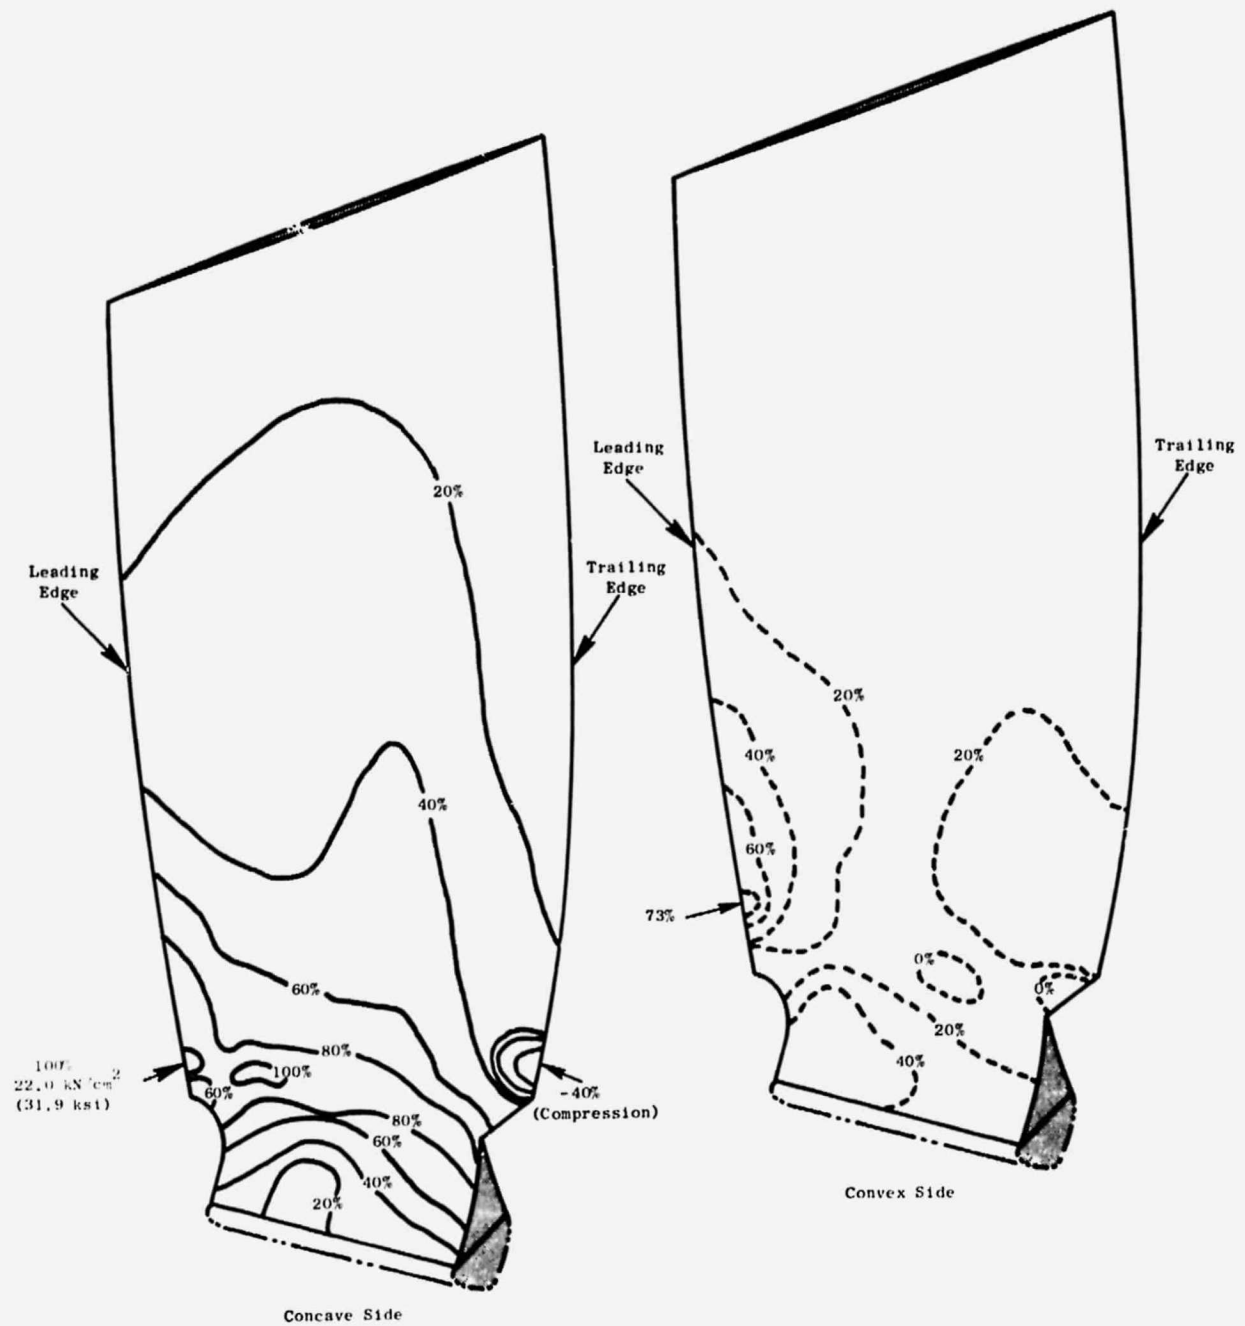
Figure 4. Calculated Blade Radial Stress.

The blade stress and vibratory characteristics were determined from a three-dimension finite-element analysis, blade bench testing, and single-blade spin testing. Figure 4 is a map of calculated radial steady-state stresses for the concave and convex blade faces, and Figures 5, 6, and 7 show calculated relative radial stresses over the blade for the first three vibratory modes. The maps of relative radial stresses under vibratory conditions show the changes in stress locations for the different vibratory modes. Blade bench and whirligig test data agreed closely with these predictions.

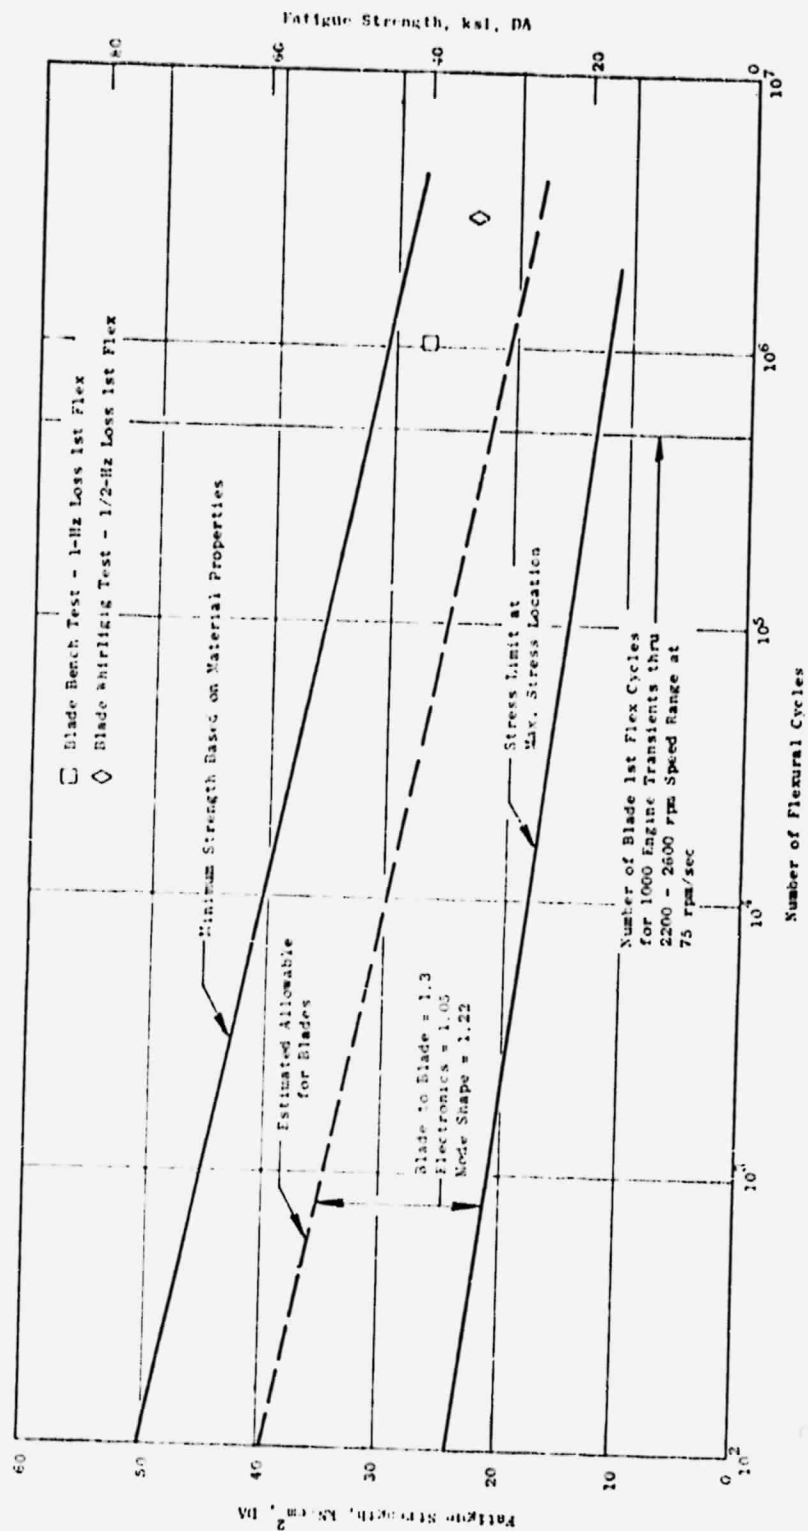
Figure 8. Fatigue S-N Curve for QCSEE Blade.

Blade vibratory strengths were determined from specimen and QCSEE blade tests and are shown on the fatigue S-N curve (Figure 8), and the fatigue stress-range diagram (Figure 9). The fatigue S-N curve shows the maximum blade stress for various numbers of flexural cycles that will cause the blade to initiate delamination and cause loss of blade frequency. The upper curve gives the minimum strength of the composite material based on flat specimen, axial-axial fatigue testing. The allowable blade fatigue strength was based on the material minimum-strength curve and blade high-cycle-fatigue test data. It includes allowance for three standard deviations of strength property variation. The lower curve defines the stress limits for engine testing and was determined using various factors which are discussed under "scope limits". The fatigue stress-range diagram shows the allowable radial alternating stress as a function of the blade mean stress. The allowable stress levels for this curve were selected as the point on the S-N curve for allowable blade stress where no loss in frequency would occur after 1,000,000 flexural cycles with allowance for 3 standard deviations of material property variation. Measured strains in the blade radial (spanwise) direction along with a material modulus of elasticity of 6.9×10^6 N/cm² (10×10^6 psi), were used to calculate all stresses and strengths. This approach provided a consistent basis for setting scope limits, gage monitoring, and comparing stresses during the various phases of blade testing. Blade "instability" or "limit cycle variation" was a primary consideration in the blade design. Detailed discussion of this is covered in Reference 1.

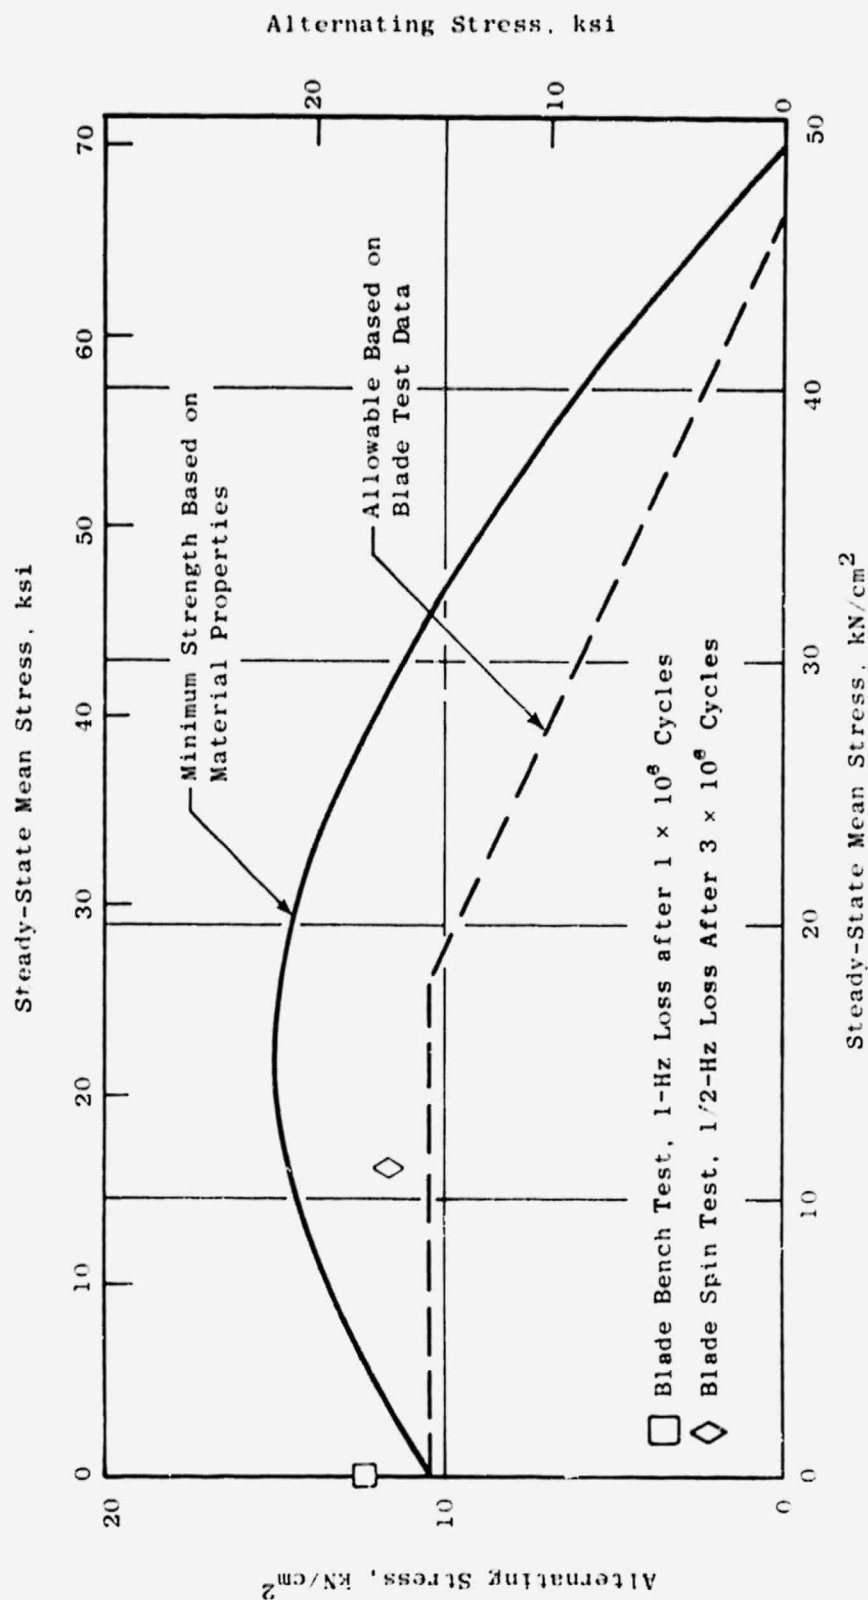
Figure 9. Allowable Stress-Range Diagram - Blade Radial Stress.

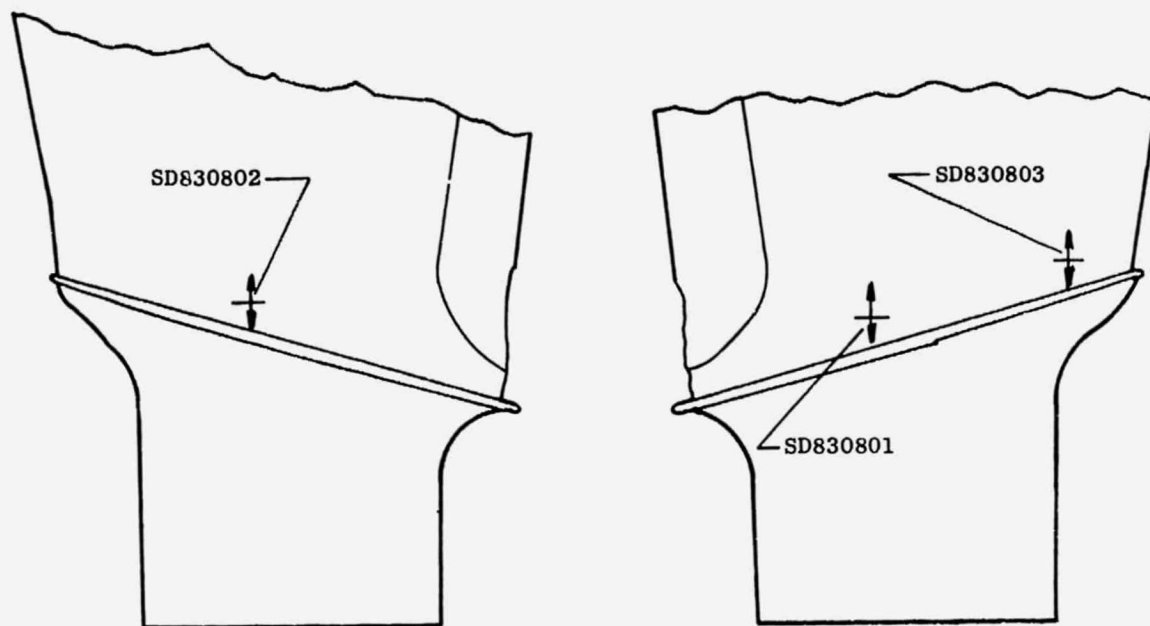
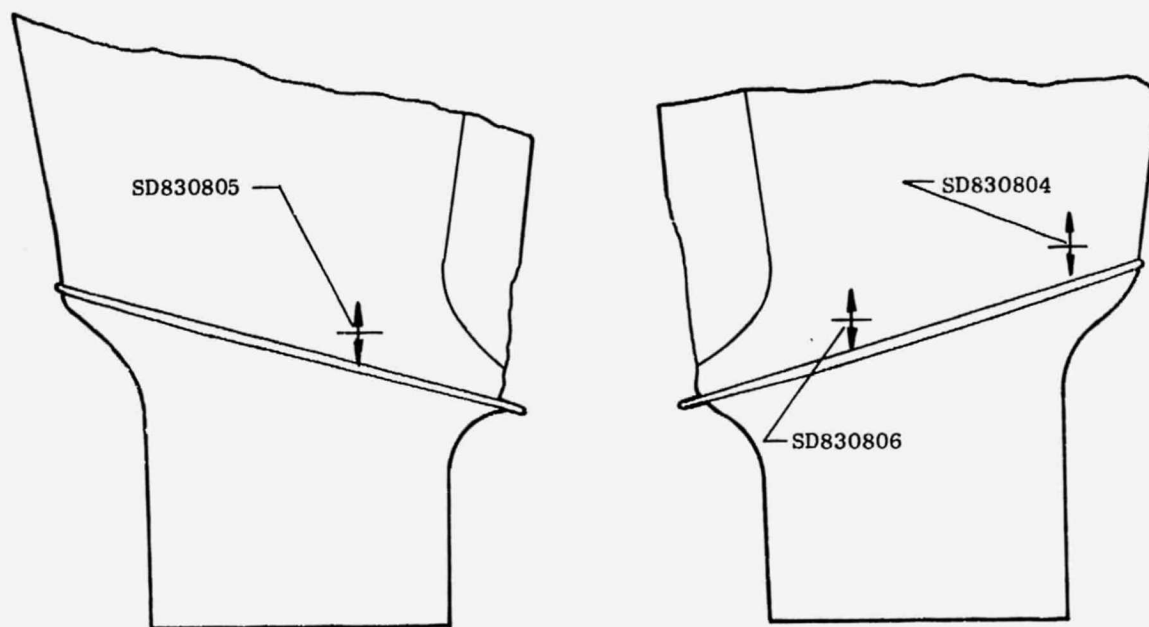
Figure 10. Locations of Fan Blade Instrumentation.

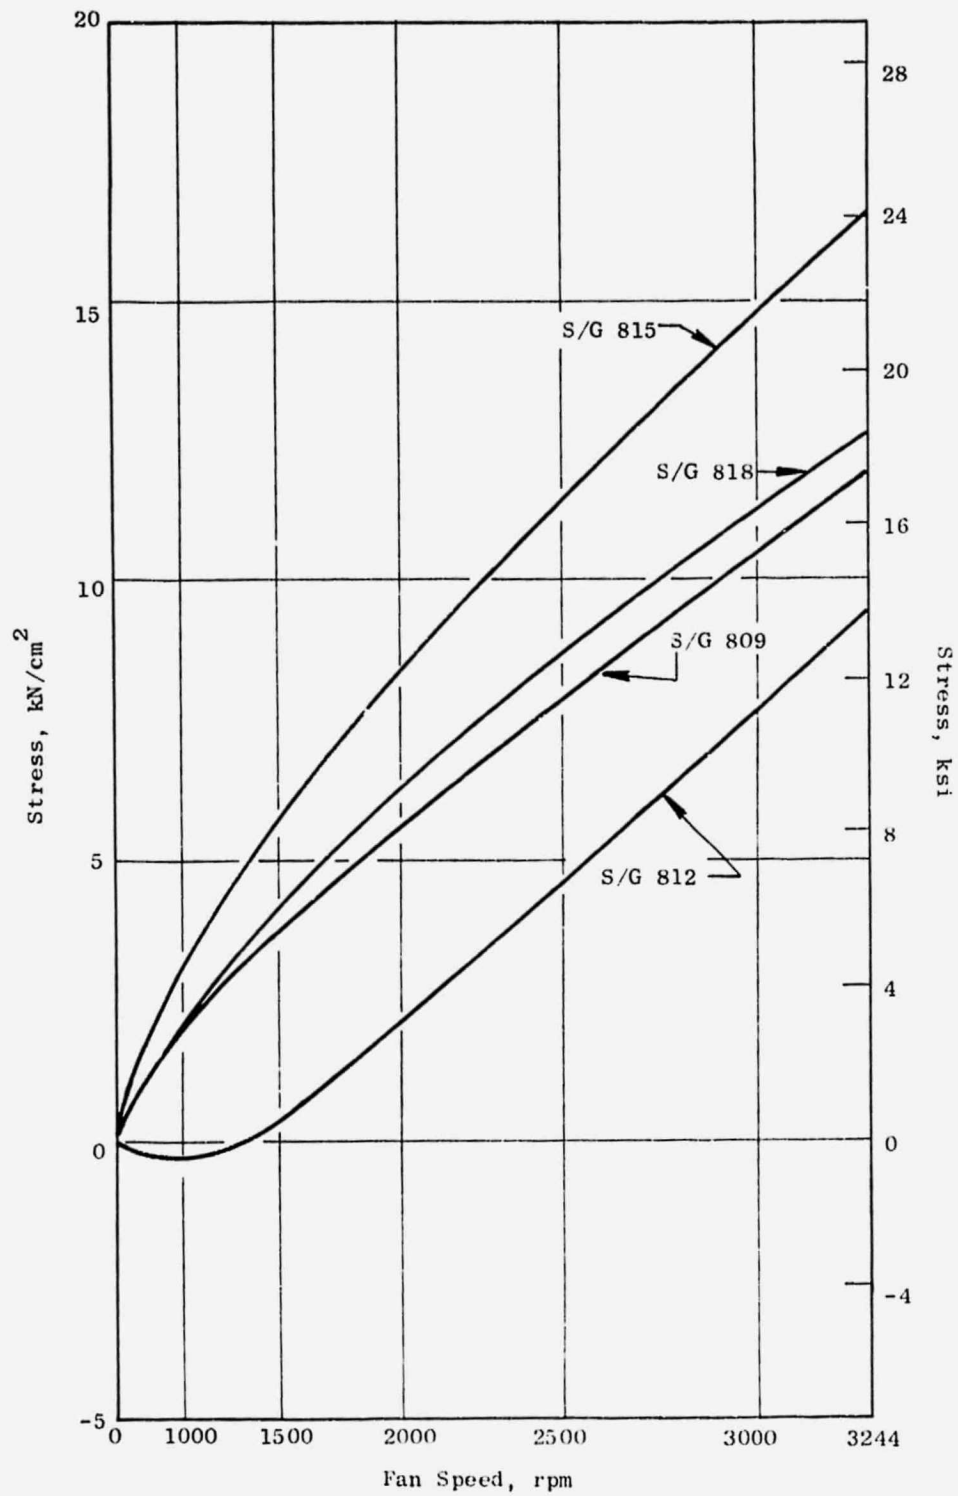
Figure 13. Steady-State Stresses, Forward Mode.

The steady-state stresses during forward mode testing are plotted as a function of fan speed in Figure 13 and during reverse mode in Figure 14. These data were taken from the Sanborn charts at points where speed changes were moderately rapid and temperature changes were very small. Therefore, it was unnecessary to correct for apparent strain temperature effects.

The forward mode testing data show that the maximum measured stress was at the airfoil midchord, concave side, slightly above the platform (S/G 815) and was 15 kN/cm^2 (22 ksi) at 3100 rpm. Gages on opposite sides of the blade at the same chord and spanwise location, and slightly aft of the maximum-reading gage (S/G 818 on concave side and S/G 812 on the convex side), had stresses of 12 kN/cm^2 (17 ksi) and 8 kN/cm^2 (12 ksi), respectively, at 3100 rpm. Root stress on the concave side, S/G 809, was approximately 11 kN/cm^2 (16 ksi) at this same speed.

Based on the finite element analysis, the calculated stresses for forward mode operation for the locations of S/G 815, 818, 812, and 809 were 18, 16, 4, and 12 kN/cm^2 (26, 23, 6, and 17 ksi), respectively. Comparison of the observed stresses to the calculated stresses shows the concave-side stress to be lower and the convex-side stress higher than calculated, and that bending is less severe than calculated. This is as expected, since the finite-element analysis conservatively assumed fixity at the blade root, whereas the actual blade has the ability to rotate at the dovetail and to reduce the blade bending. The results of these data indicated that the blade design is acceptable for steady-state stresses.

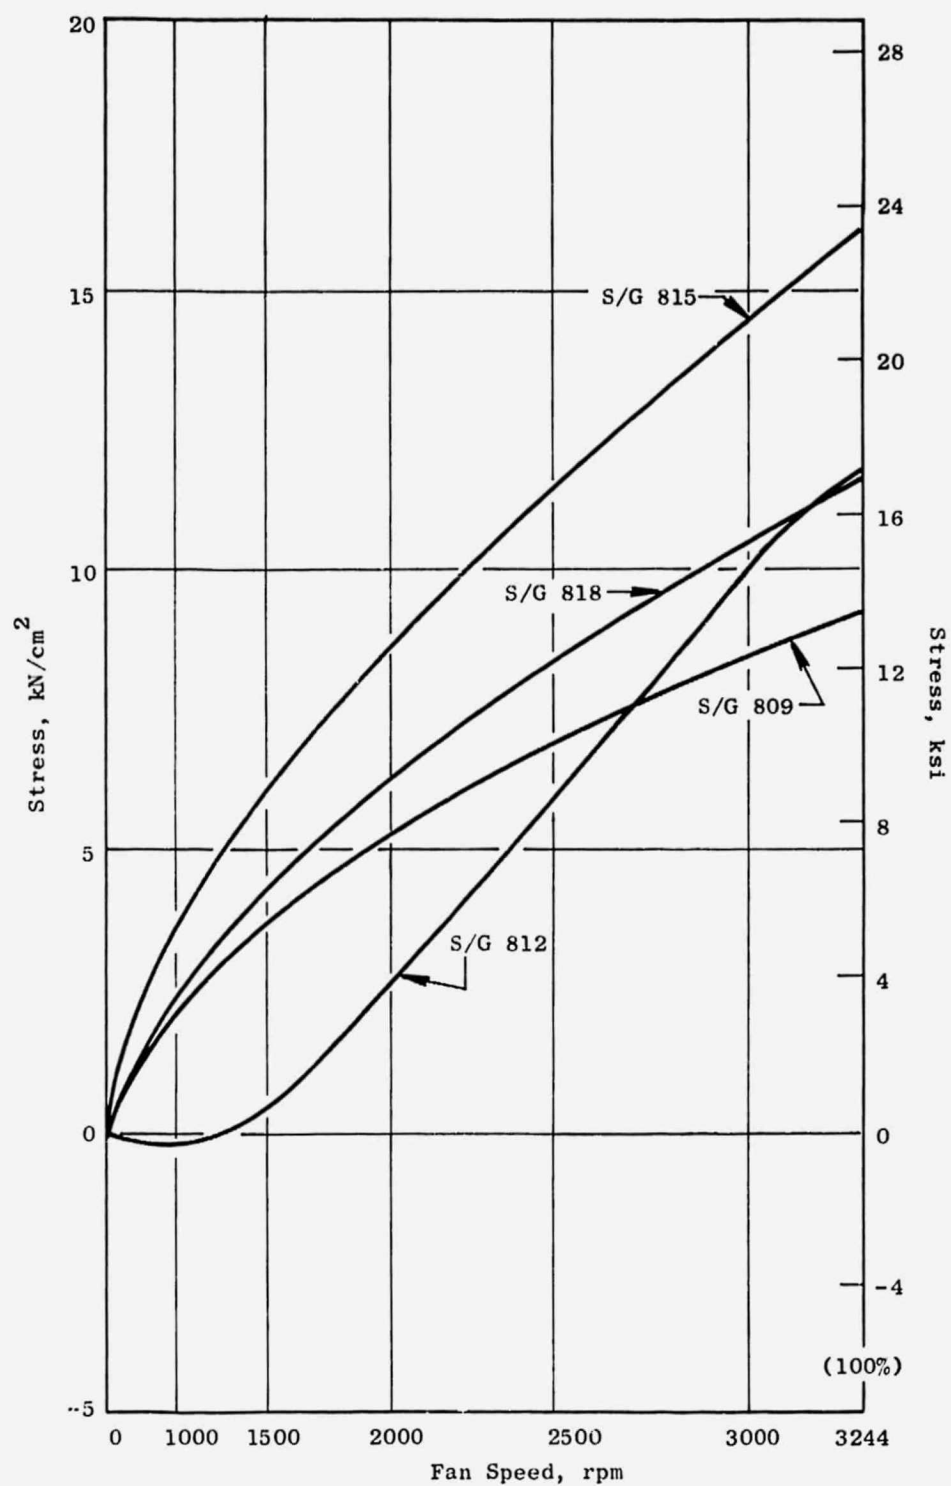
Figure 14. Steady-State Stresses, Reverse Mode.

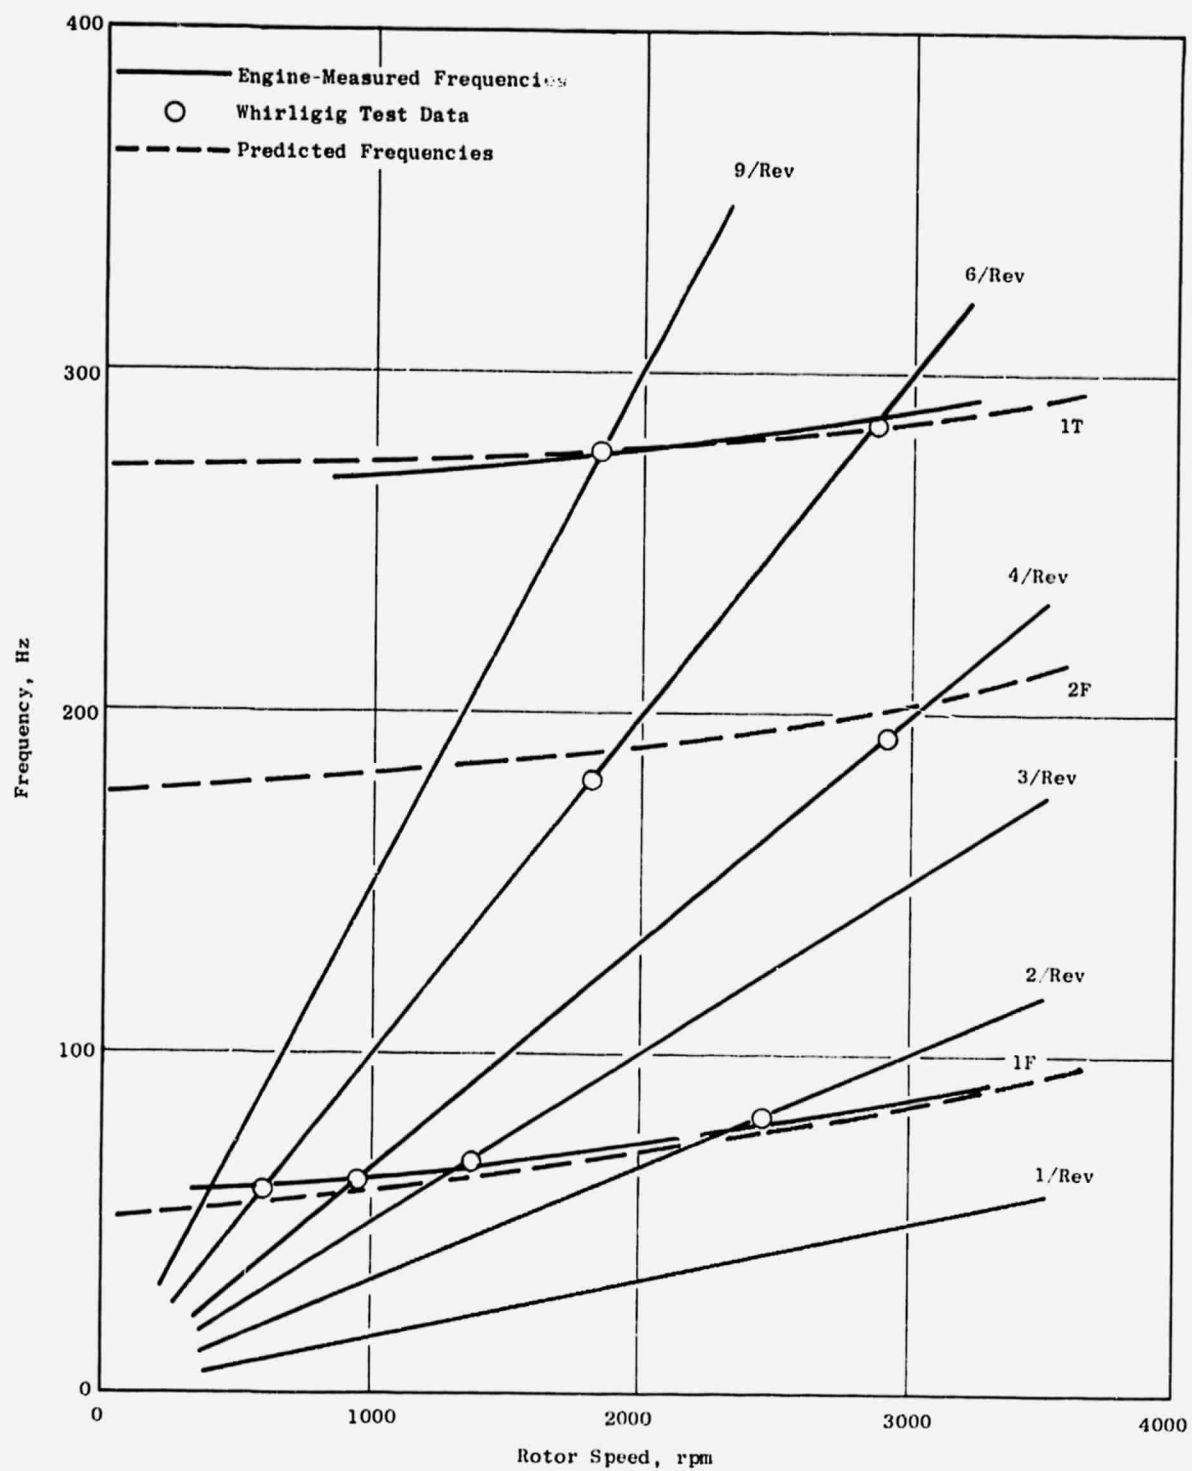
Figure 15. Campbell Diagram.

The pre-engine-test Campbell diagram for the UTW blade assembled in the trunnion and disk was determined from single-blade whirligig spin testing. This is presented with the frequencies observed during engine test in Figure 15. The plotted frequencies reflect the coupled frequency of the blade trunnion assembly and agree closely with predictions. The flexural frequency at the 2/rev crossover was predicted to occur at about 70% of the maximum steady-state speed. This is above flight idle speed and below normal operating speed for takeoff, climb, and maximum-cruise flight conditions. It therefore was considered a transient point and not subject to continuous steady-state conditions. Blade excitation stresses at 2/rev crossover were monitored carefully during engine testing. Blade pitch control and moderate acceleration through this point were employed to prevent these stress levels from becoming excessive.

The margin for first flexural frequency over 1/rev at 115% speed is approximately 50%, and the margin for first flexural frequency below 2/rev at 100% speed is approximately 13%.

The second flexural mode crosses several per-rev lines in the operating speed range. Each of these crossings represents a potential for forced resonances; however, it takes considerably more energy to drive the higher vibration frequencies such as second flex and no problems were anticipated.

The first torsional frequency 6/rev crossover is at approximately 83% speed with the 100% speed frequency margin being approximately 6% over 5/rev. Since the excitation forces were expected to be small at the higher order crossovers, no torsional vibratory problems were anticipated during normal engine operating conditions.

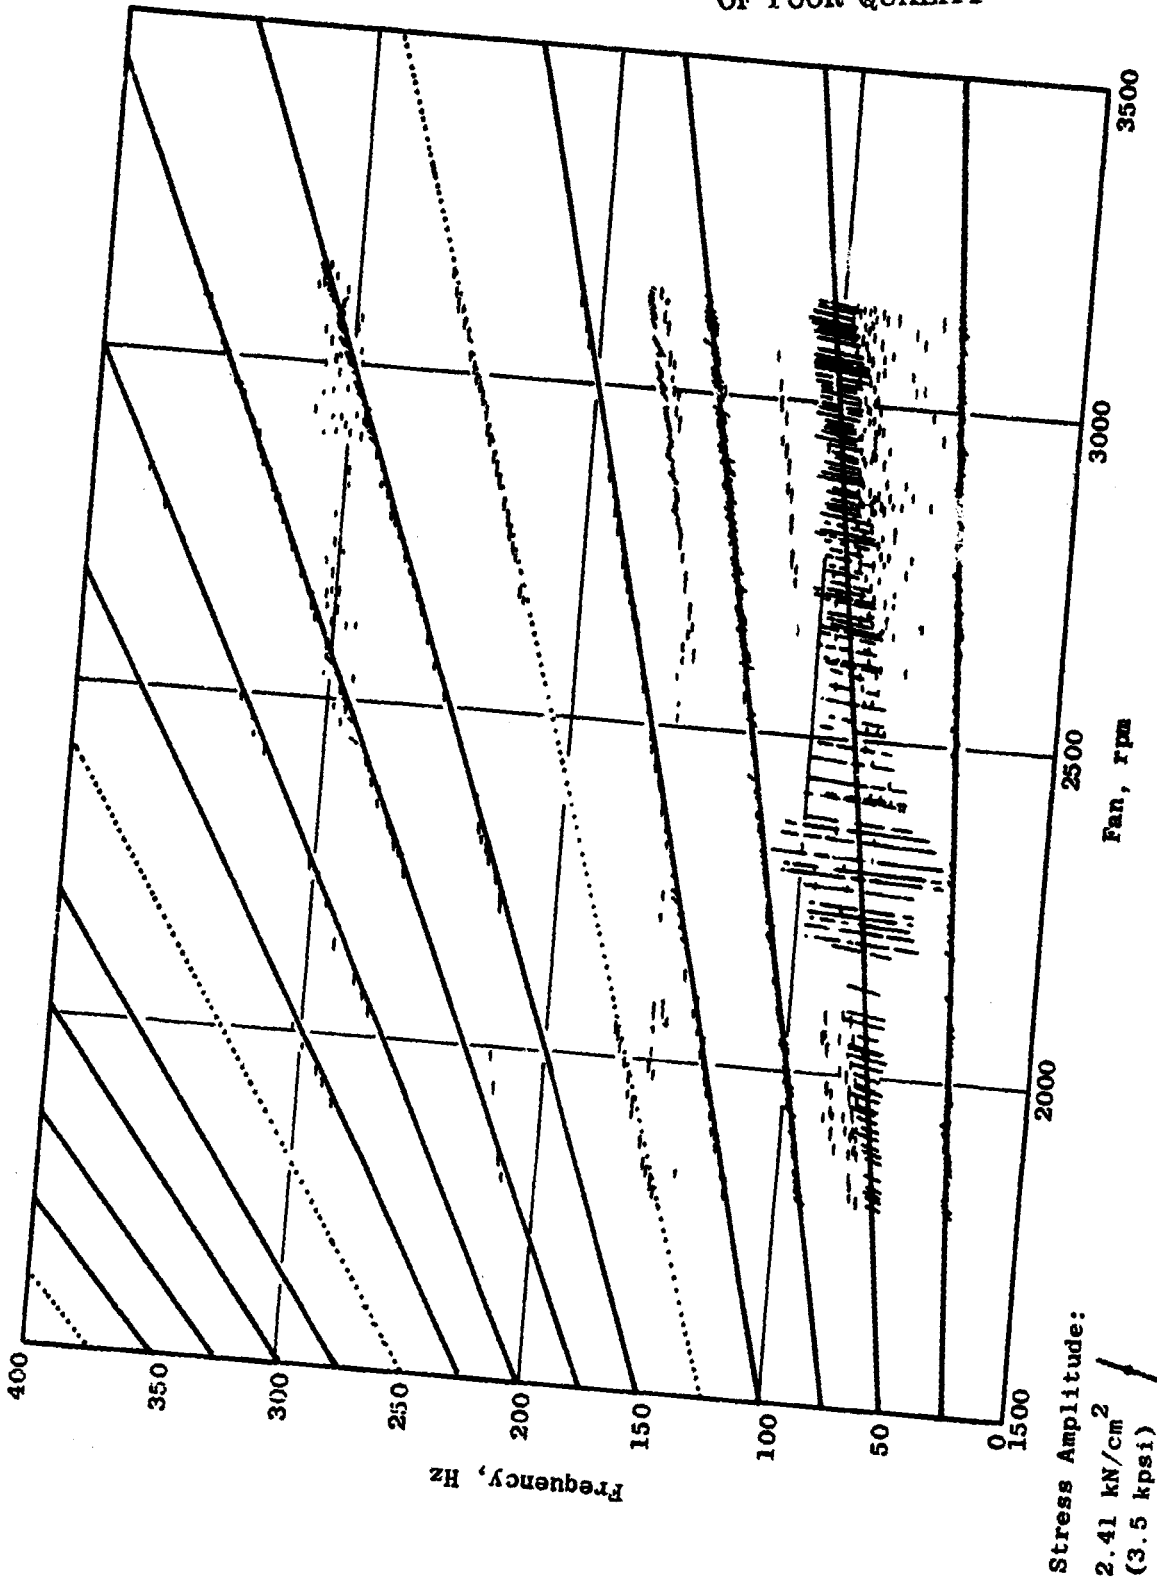
Figure 16. Dynamic Blade Stress Response.

The first flexural mode was the most active mode with responses to other modes essentially being nonexistent. Figure 16 shows a typical vibratory response for acceleration through the 2/rev crossover and through the operating region. The magnitude of vibratory stress at the various frequencies is shown by the length of vertical lines on the diagram. It is seen that essentially all stresses are in first flexural mode forced by the 2/rev stimulus.

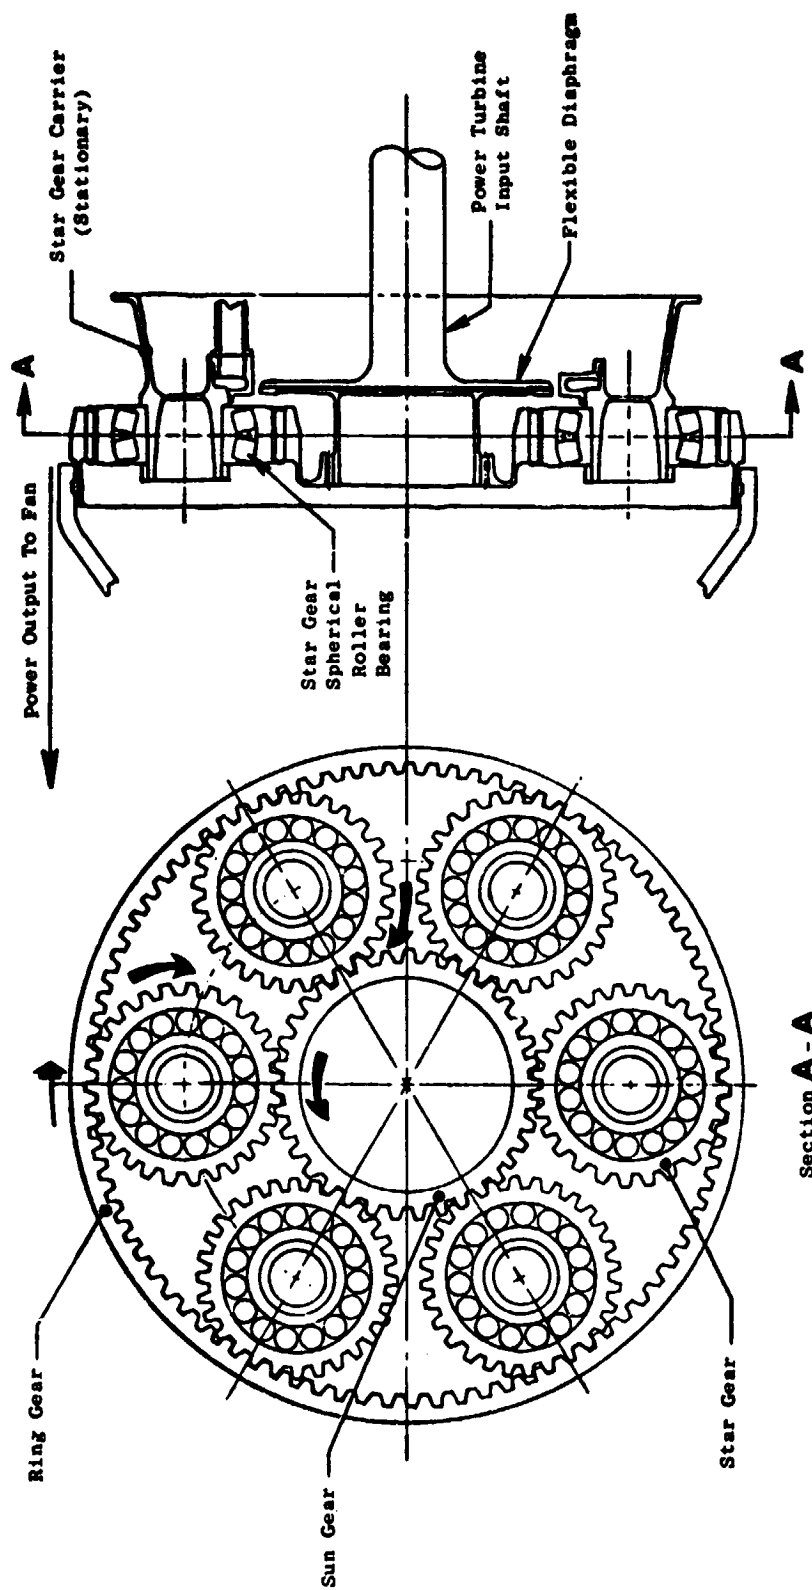
Figure 17. Main Reduction Gear Configuration.

The ring gear evidenced pitting corrosion on the exposed surfaces. Inspection indicated that the most likely cause for the corrosion was fingerprints. To avoid a reoccurrence, this gear was cleaned and a black oxide finish was applied. During the next buildup, fingerprint remover will be used on all main reduction gears prior to assembly. They then will be oiled and handled in the manner prescribed for bearings.

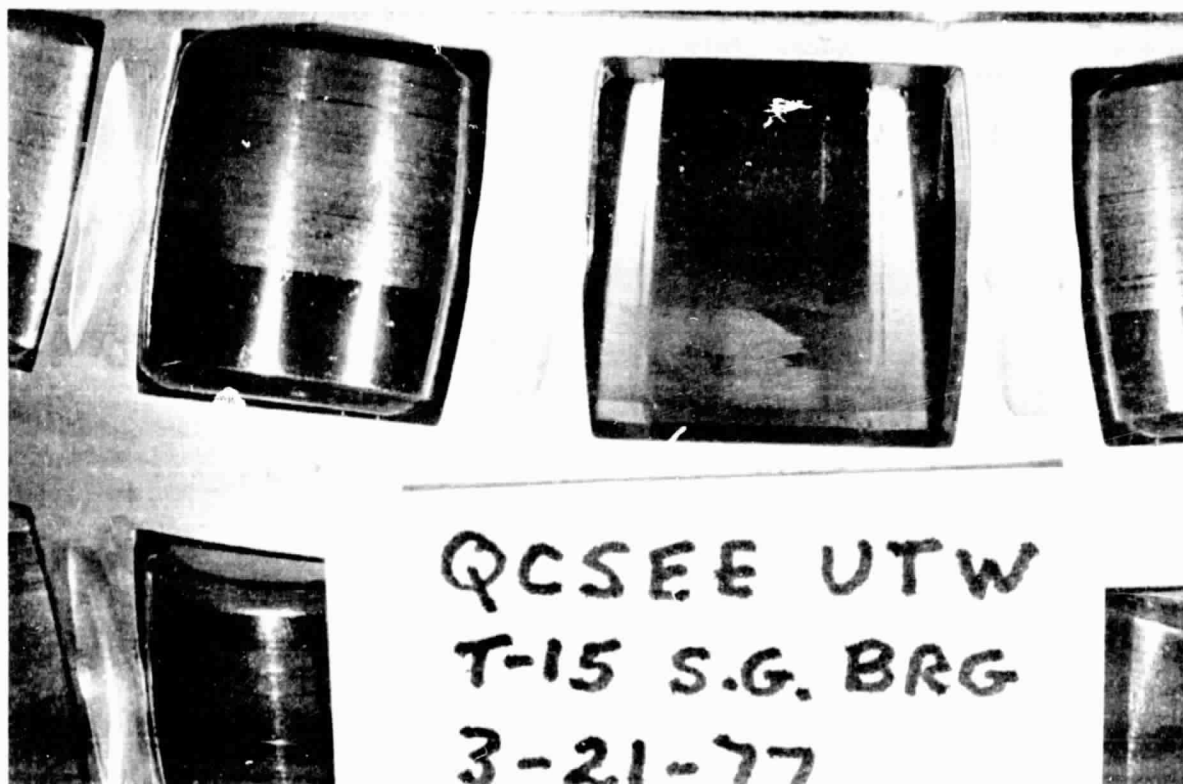
5.2.2 Bearings - One roll was removed from each bearing and both the inner and outer races were inspected. The inner race of two bearings, T14 and T15, showed skidding distress in the loaded zone. The inner race of the remaining four bearings showed no evidence of skidding. It is hypothesized that this defect was caused by the unloading of these bearings during the vibration caused during the nozzle failure incident. In order to reduce cost, the same bearings will be used in the next buildup. The defect will be rotated out of the load zone. Figure 20 shows a typical skid mark. The outer race indicated mild pitting toward the center of the raceway at the edge of the roller track. This is attributed to debris damage. Figure 21 shows the minor extent of the damage.

Figure 20. QCSEE UTW Bearing Inner Race Skidding Distress.

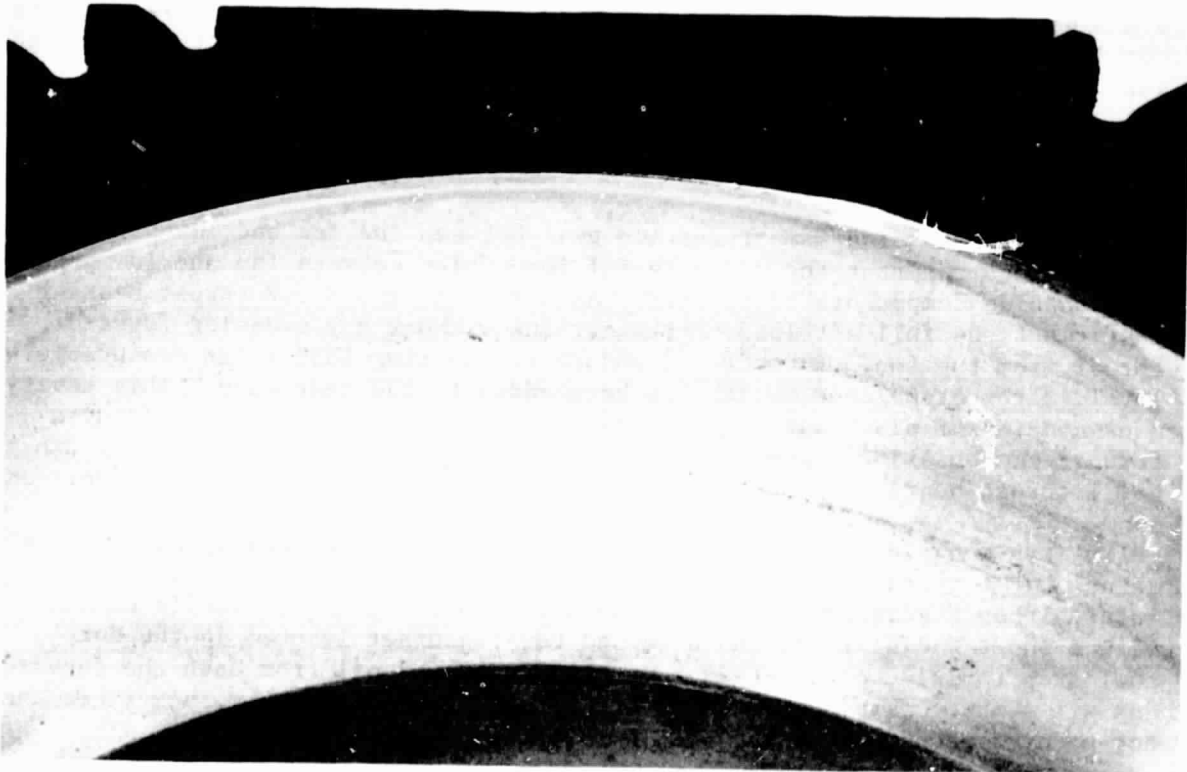
Figure 21. QCSEE UTW Outer Race Debris Damage.
